# A CENTRIFUGAL COMPRESSOR SYNCHRONOUS MOTOR CASE HISTORY

*B.C. Howes*

**Beta Machinery Analysis Ltd., Calgary, Alberta, Canada, T3C 0J7**

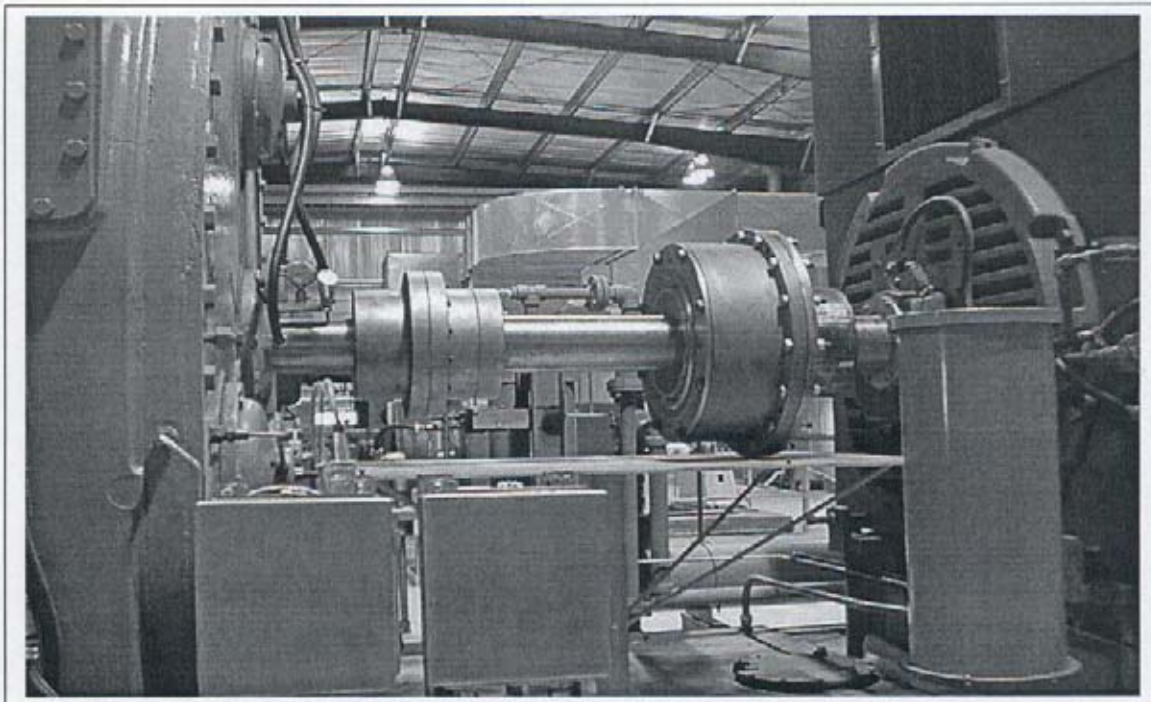
Picture 1: Gear coupling on the left, and Elastomeric coupling on the right

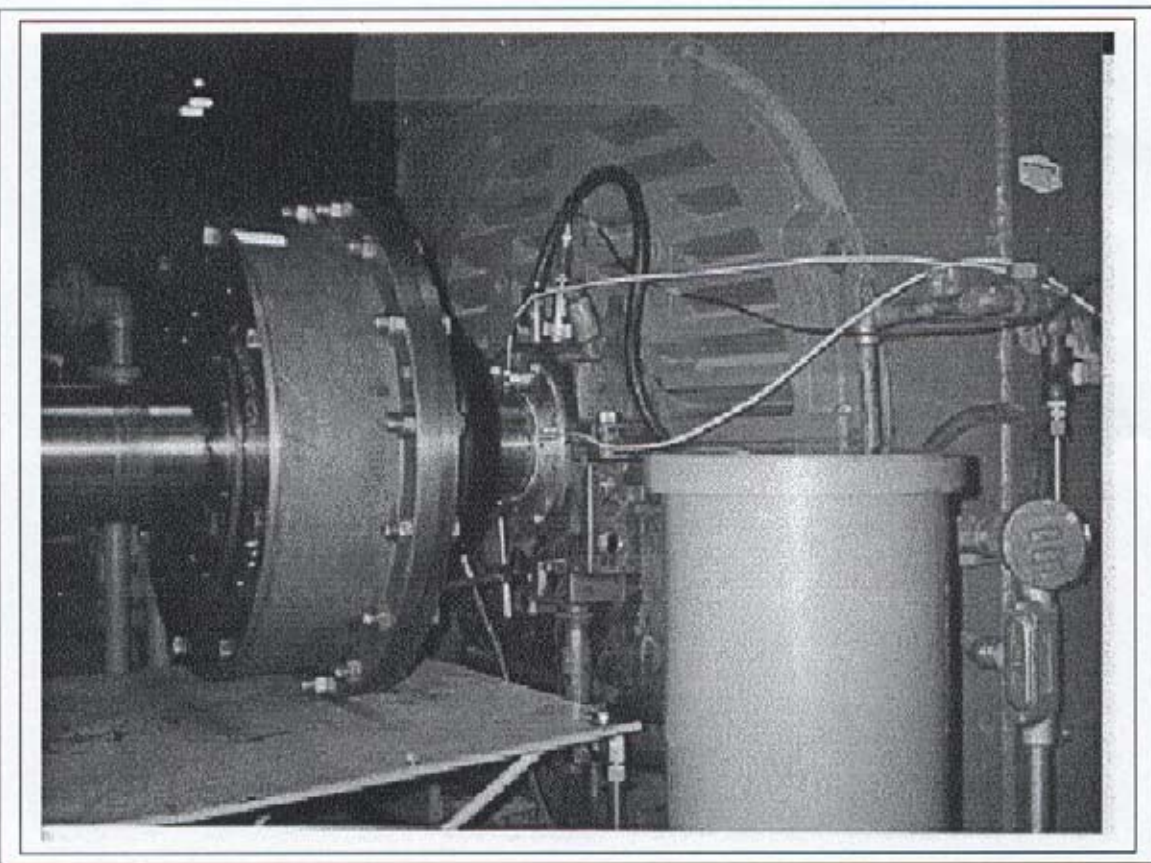
Picture 2: Motor with Elastomeric Coupling, Note: Proximity Probes

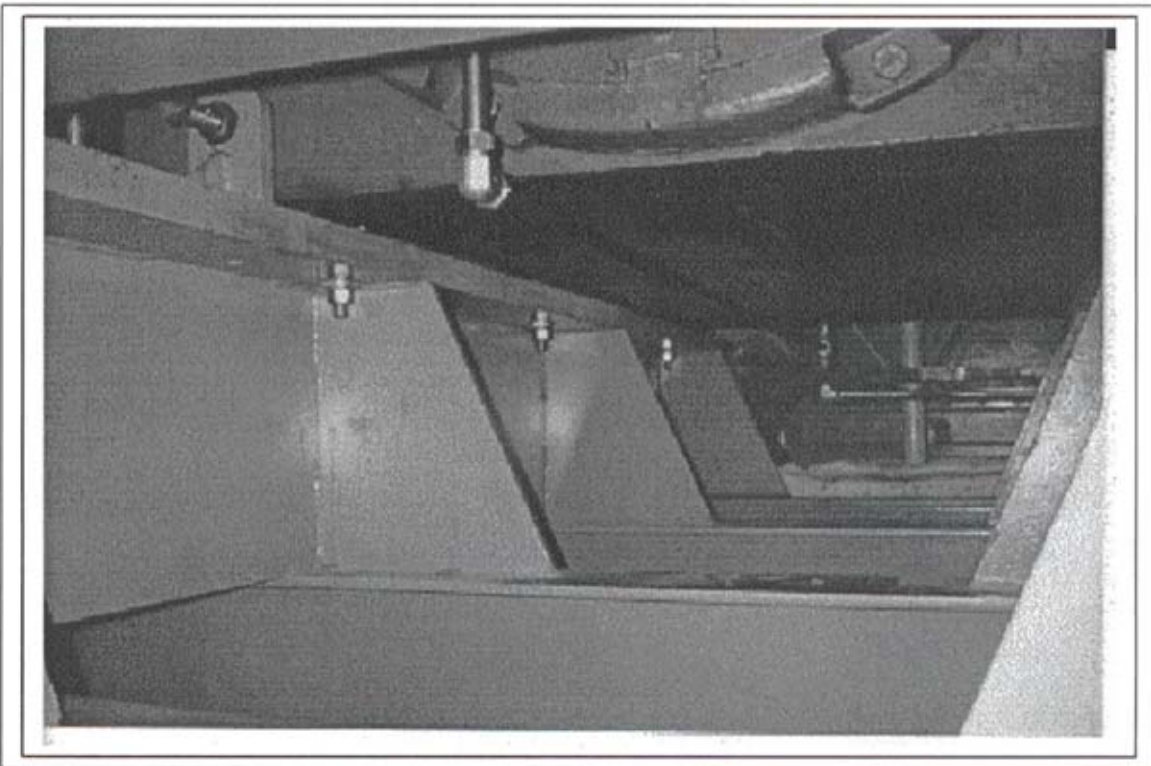
Inspection of the skid [see Pictures 4 and 5] suggested that removing some of the horizontal stiffness in the pony skid [the top part of the skid] should lower the offending MNF and reduce vibrations to acceptable levels. In a spirit of bonhomie, we embarked on the uncharted sea. Cutting progressively more and more of the gussets reduced the apparent MNF from bump testing, but was unsuccessful in reducing the vibrations at the top of the motor even though the operating deflected shape [ODS] changed [see Figure 4].

Picture 4: As Found Gussets, Pony Skid under Motor

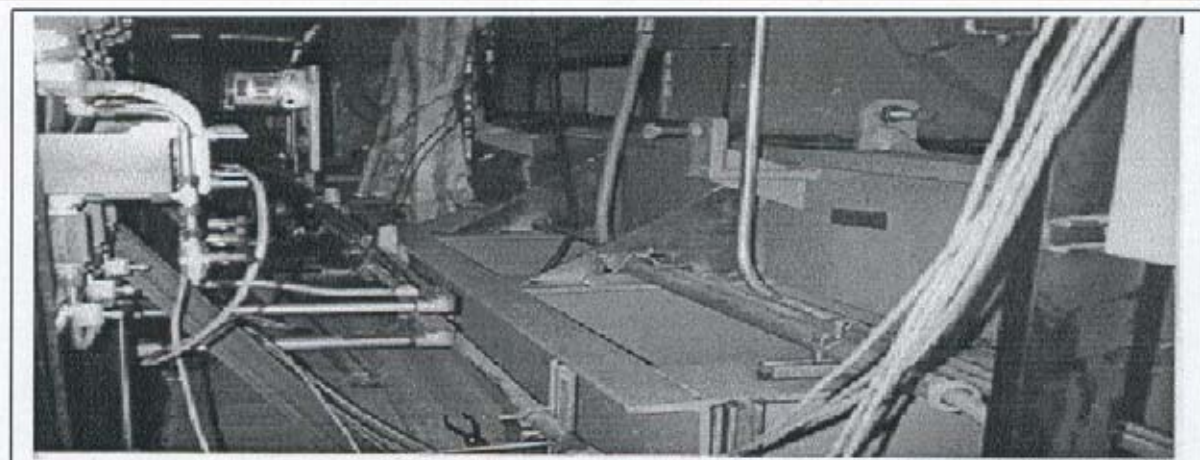
carefully numbered in case of this very eventuality] were welded back in place, and additional gussets were welded to the outside of the pony skid [see Picture 6]. The result of over-tuning was not entirely clear as we were unable to achieve enough separation between the bump test MNF and run speed. However, the ODS plot shown in Figure 4 indicates that the problem is likely due to the movement of the motor relative to the skid across the shim packs. This movement appears to be non-linear. Hence the apparent improvement in MNF without significant improvement in running vibrations.

Picture 6: External Gussets added to motor pony skid

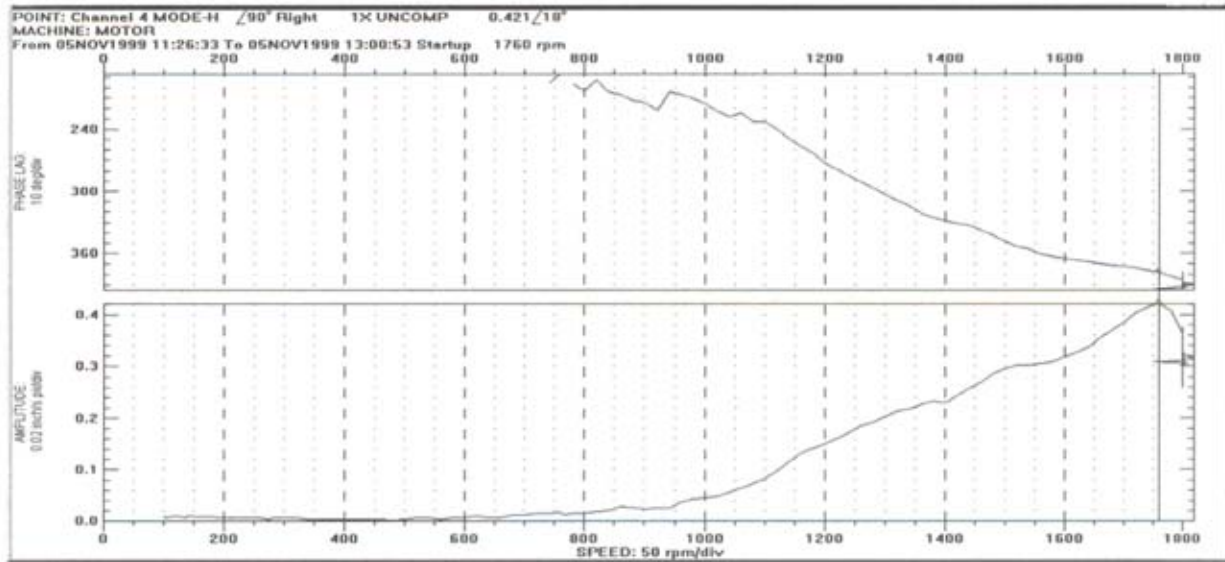
The motor horizontal vibrations showed that a structural resonance or mechanical natural frequency [MNF] was present very close to run speed. This showed another reason why the unit had had so many maintenance problems over its life. Bump tests were performed that confirmed the proximity of an MNF to run speed. Note that there is a 180 degree difference in phase between the ends of the motor in Figure 1 and 2.

Figure 1: Rundown vibration plot for the motor outboard end, horizontal [6 gussets cut]

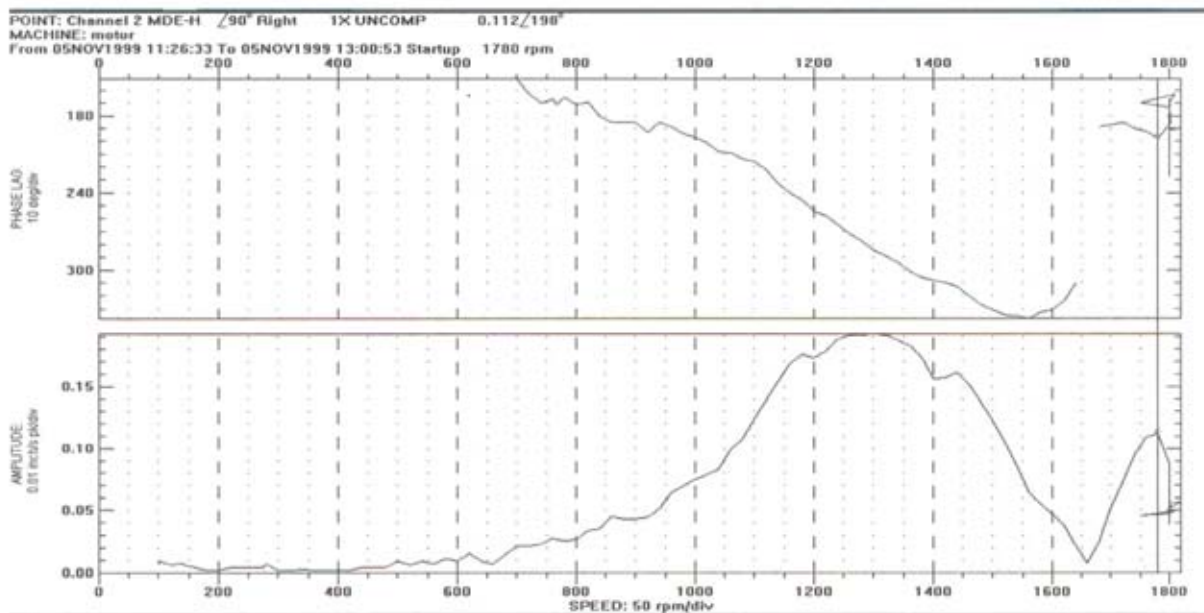
Figure 2: Rundown vibration plot for the motor inboard end, horizontal [6 gussets cut]

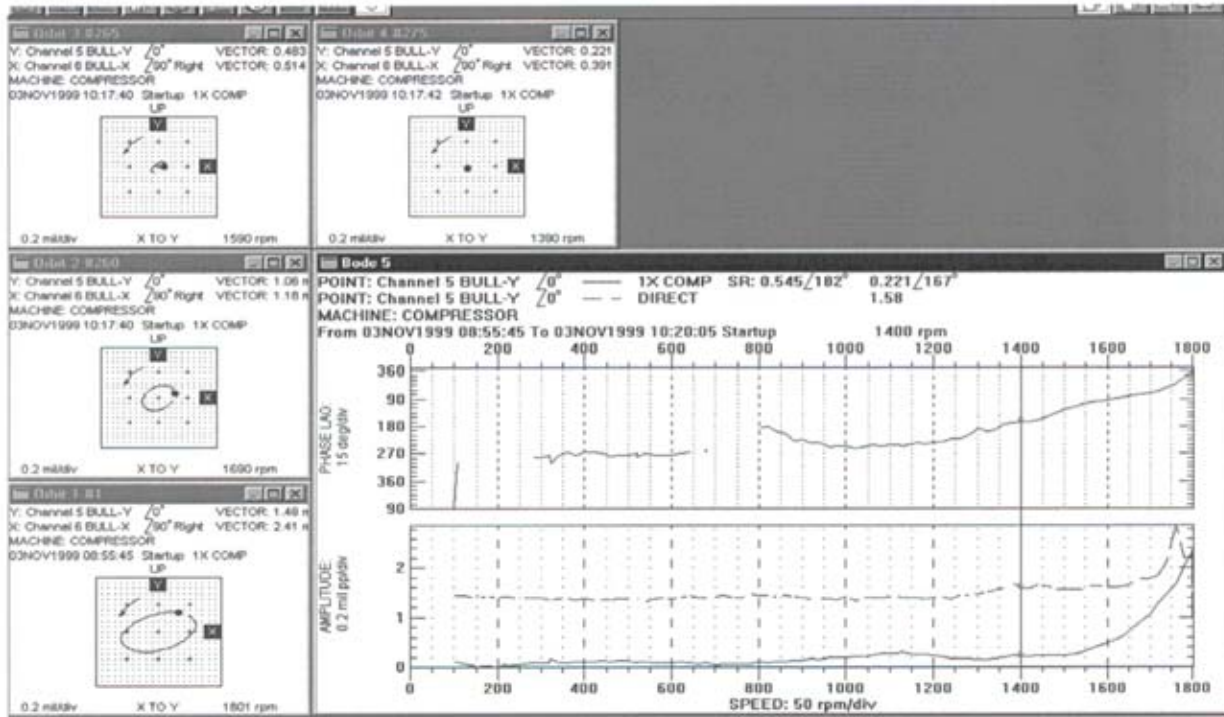
It is also apparent that the long-term runability of this unit is not likely to be good since the compressor shaft exhibits a shaft critical near run-speed [Figure 3]. As long as the alignment and coupling balance are kept to very good standards, the vibrations will be acceptable. The sensitivity to small changes in balance and alignment remains of concern.

Figure 3: Rndown vibration plot for the gearbox drive end, shaft relative to housing [The vibration increases from 1600 to 1800 rpm by 4.7 times while the ratio of the speed squared is 1.26. Resonance is suspected.]

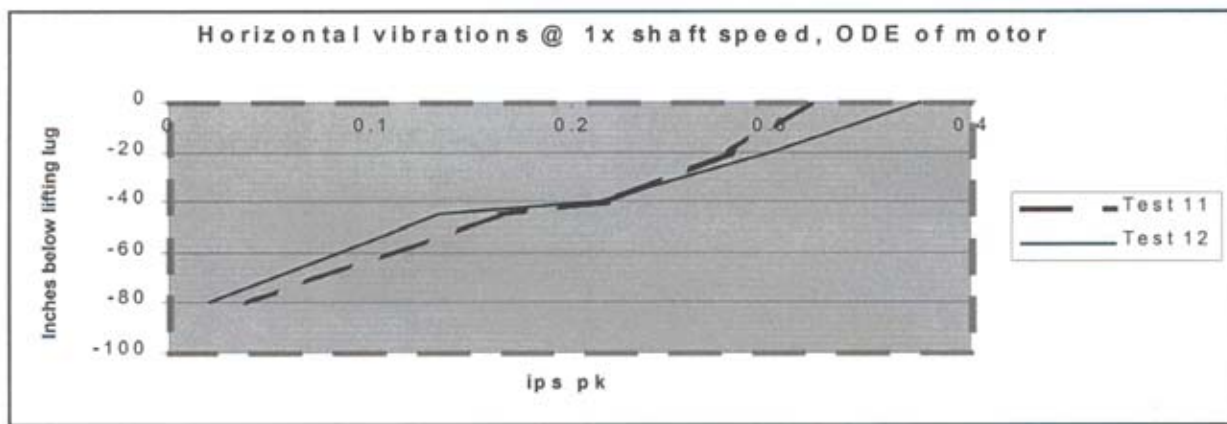
Figure 4: Operating Deflected Shape [ODS] of motor outboard end with gussets cut out [Test 11, see Photograph 4] and with gussets replaced plus external gussets added [Test 12, see Photograph 5] Note the discontinuity at the -45 inch level. The shim pack between the motor feet and the top of the pony skid is at this level. Bump testing showed the horizontal out-of-phase mechanical natural frequency of the motor was about 23 Hz for Test 11 and 32.5 Hz for Test 12.]
