# **Pipeline Station Pulsation Case Study: Minimal Piping Change Creates Complicated Problems**

keywords: reciprocating compressor, centrifugal compressor, pulsation, vibration, pipeline station vibration analysis

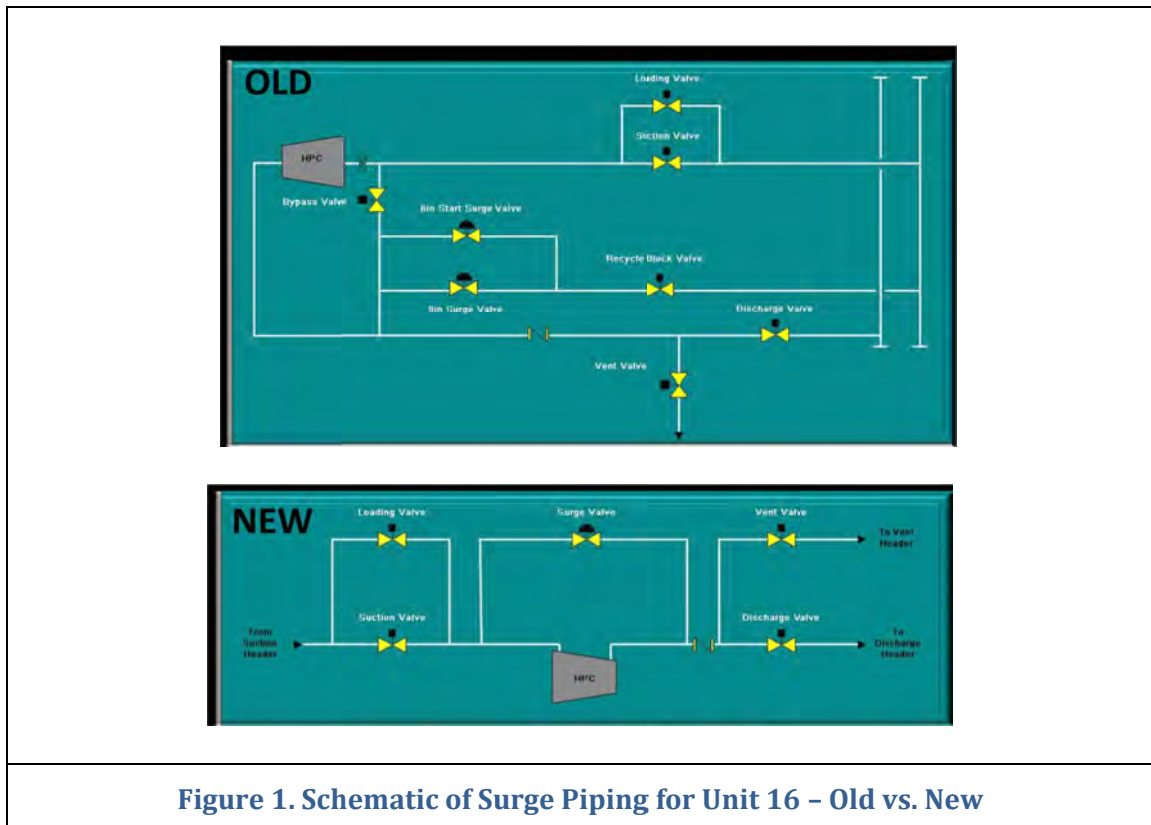
**Figure 1. Schematic of Surge Piping for Unit 16 – Old vs. New**

- In the late 1990s the horsepower on Unit 16 was updated from 12600 to 15000 HP and it was at this time Unit 16 started having vibration problems. A short piece of pipe was added to the discharge header to reduce vibration levels.
- In 2010 Unit 17, a centrifugal compressor, was added.
- In 2011 piping in the cooler area was modified to accommodate additional gas coolers that were added.
- In 2011 the surge piping on Unit 16 was modified; four surge/bypass valves were removed and replaced with one surge valve, see Figure 1.

The 2011 change to the Unit 16 surge piping was the “straw that broke the camel’s back.” The resulting piping failures illustrate how piping changes can create unintended consequences, such as:

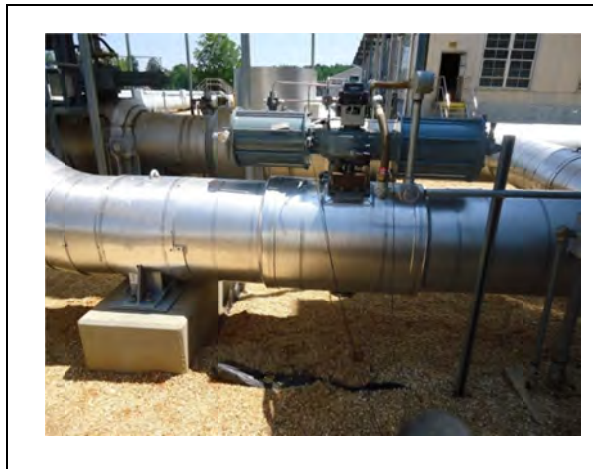
**Figure 2. Unit 16 Surge Valve Operator**

- High piping vibration was taking place in the header.
- The surge valve operator, as well as other piping, was now showing signs of high vibration.
- The vibration of small bore attachments was bad enough that it was anticipated a failure would occur.
- In December of 2011 a small bore nipple, located on the Unit 14, 15 and 16 common header, failed.

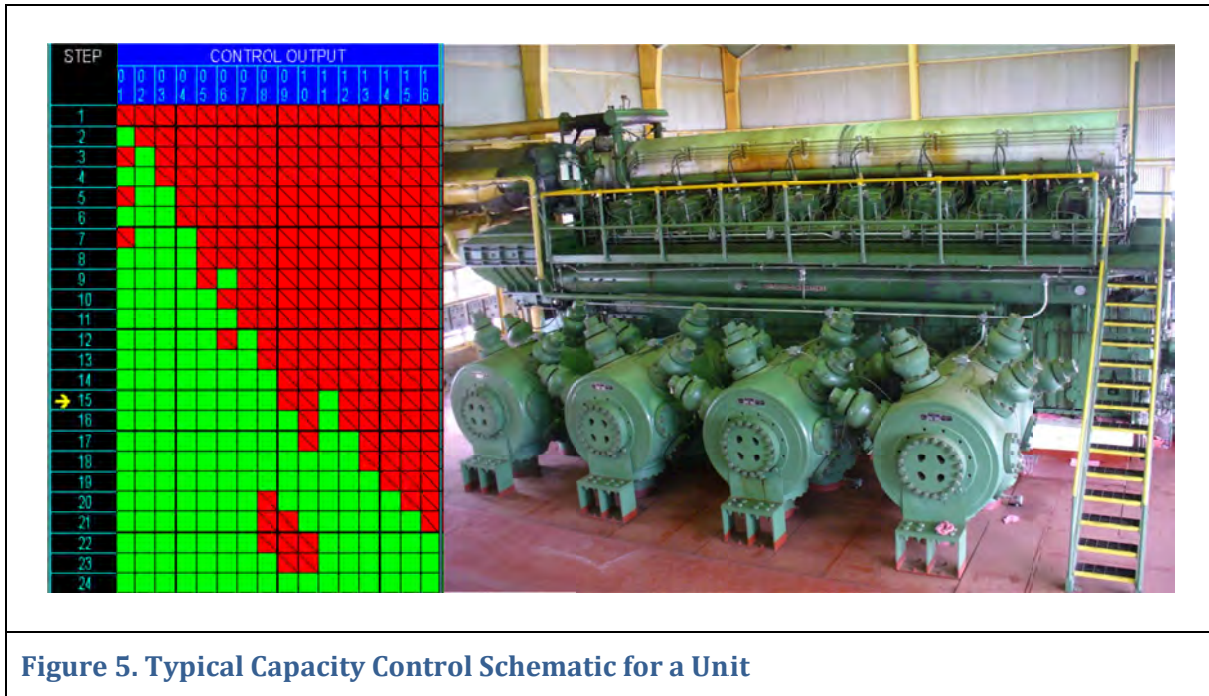
Figure 5. Typical Capacity Control Schematic for a Unit

The 16 compressors that are acoustically tied together can be operated independently creating literally hundreds of potential operating scenarios. There are as many as 24 different load steps for most units, as seen in Figure 5. As well, the interaction of pulsations between compressors, multiple headers and parallel paths to the coolers create many opportunities for acoustical resonance.

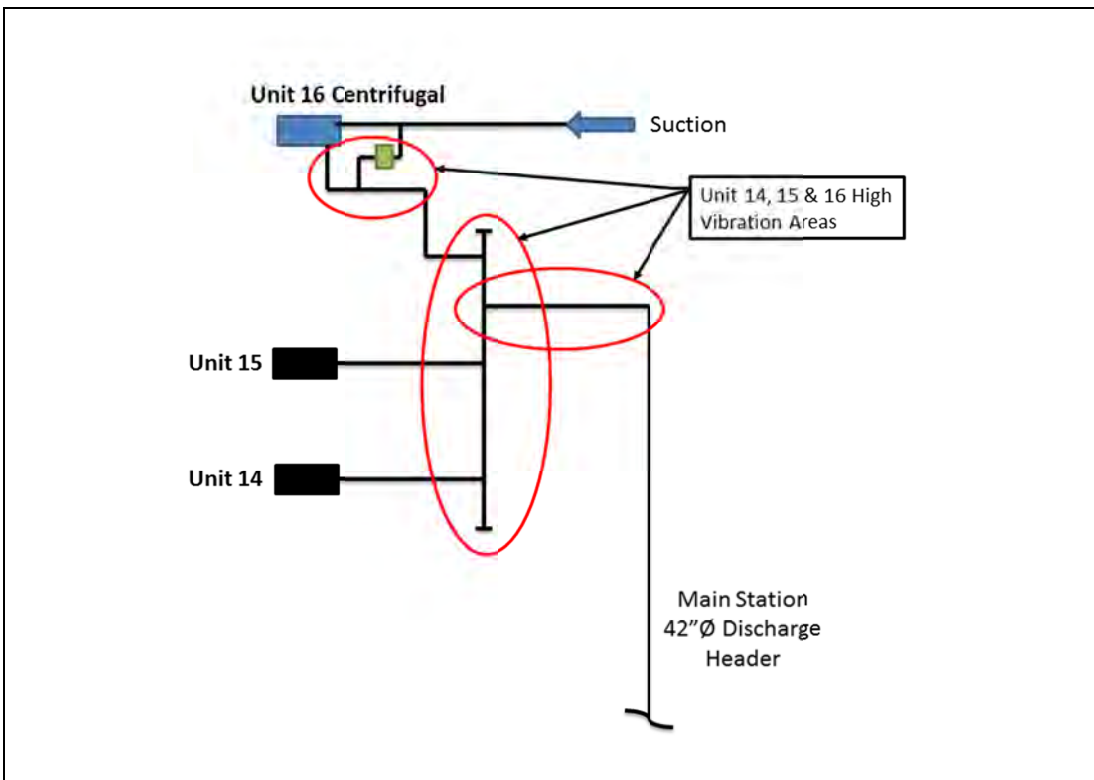
**Figure 8. Unit 16 Schematic**

Really high shaking forces in the Unit 16 centrifugal compressor discharge lateral piping were driving the connected surge piping, see Figures 8 and 9.

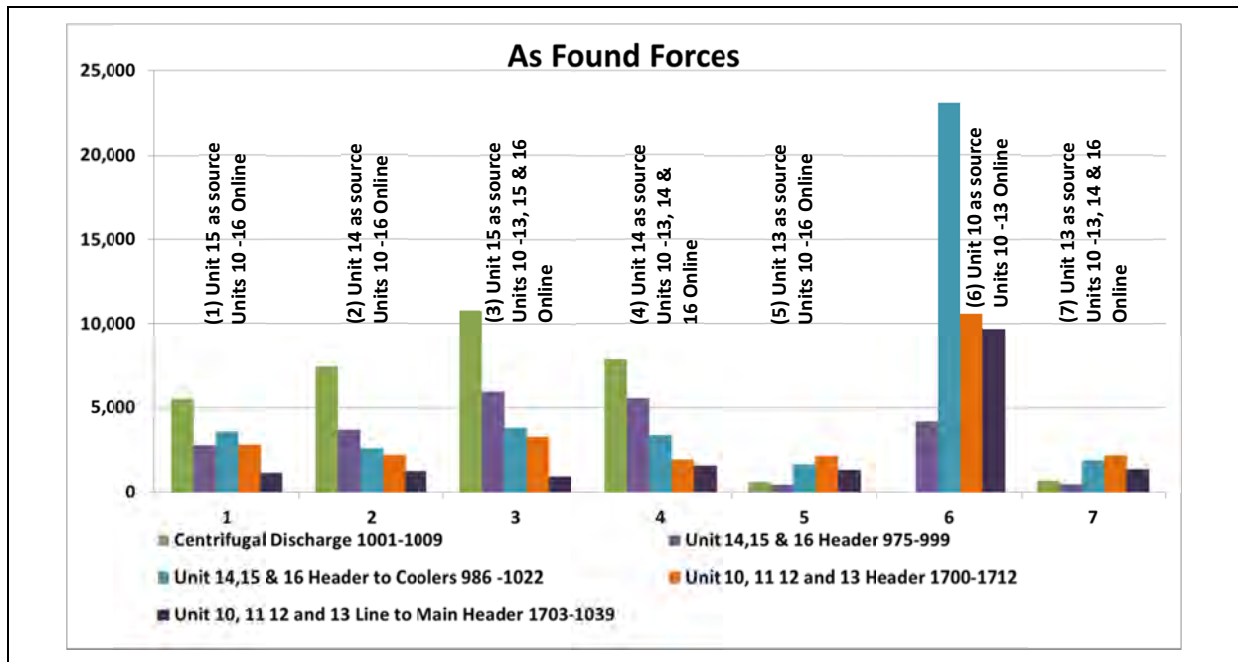
**Figure 11. High Shaking Forces Vary with Units Online**

The model also confirmed that the shaking forces, hence the vibration, in a given area varied greatly depending on which unit is considered as a source of pulsation, as well as, how many units are online. Figure 11 summarizes how shaking forces in the existing system change as the number of units online and offline changes. For example:

- Comparing forces in Group 1 to Group 3:
  - Group 1 shows the shaking forces in a few key problem areas around Unit 16 with Units 10 through 16 online and Unit 15 as the source of pulsation.

- Group 3 is the same acoustical model, except Unit 14 has been taken offline.
  - The shaking forces in the Unit 16 lateral piping and the common header for Units 14, 15 and 16 double in amplitude by having one less unit online.

- Group 6 helped to validate the model against what operators were experiencing in the field. Some of the highest vibration in the area of Unit 16 occurred with Units 14, 15 and 16 were all offline. This operating scenario had the highest shaking forces in the Unit 14, 15 & 16 header.

- Comparing forces in Group 5 to Group 7:
  - Group 5 shows the shaking forces in a few key problem areas around Unit 16 with Units 10 through 16 online, and Unit 13 as the source of pulsation.

- Group 7 is the same acoustical model, except Unit 15 has been taken offline.
  - In this case, the shaking forces change very little when one less unit is online.

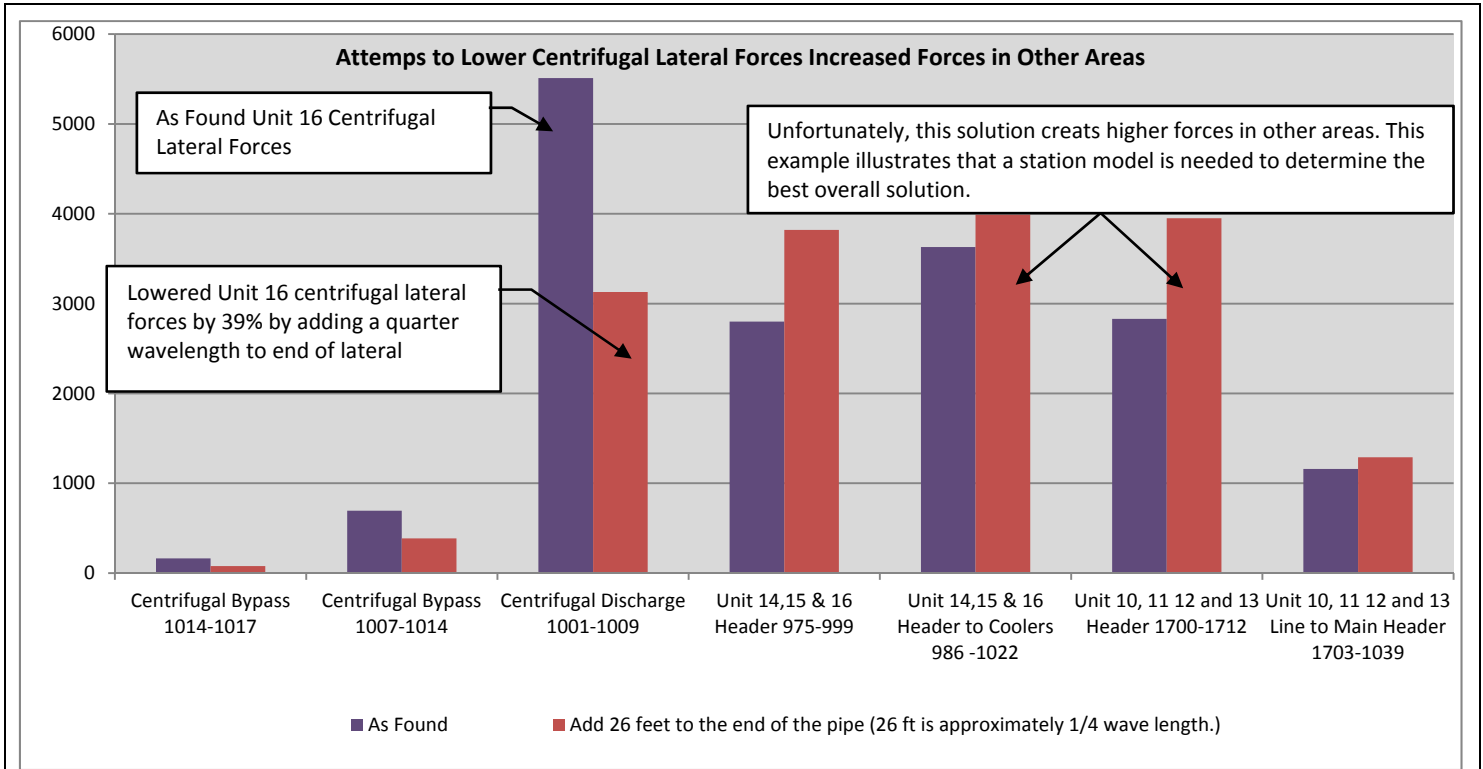
**Figure 12. Attempts to Lower Centrifugal Lateral Forces Increased Forces in Other Areas**

Evaluation using standard pulsation theory ended up at a dead end. Each time a potential solution was identified it reduced forces in one area and created a new problem in another area. As shown in Figure 12, adding a quarter wave resonator off the Unit 16 discharge piping had a big impact in lowering the shaking forces that were exciting the surge valve, but increased some of the forces that resulted in the small bore failure on the Unit 14, 15 and 16 header.

Since there is no perfect solution to this complex problem, the design team focused on finding an optimal approach. The final solution involves removing the header for Units 14, 15 and 16 (eliminates some of the problem pipe spans) and discharging units 14, 15 and 16 directly into the 42 inch diameter common header. There will also be some speed limitations for the rare operating case where any two or three of Units 14, 15 & 16 are offline at the same time. Restraint speed on a couple of units was an acceptable solution for the operations team.
